BROWN SHANTY LAKE DAM

GASCONADE COUNTY, MISSOURI

MO 30187

PHASE 1 INSPECTION REPORT NATIONAL DAM SAFETY PROGRAM

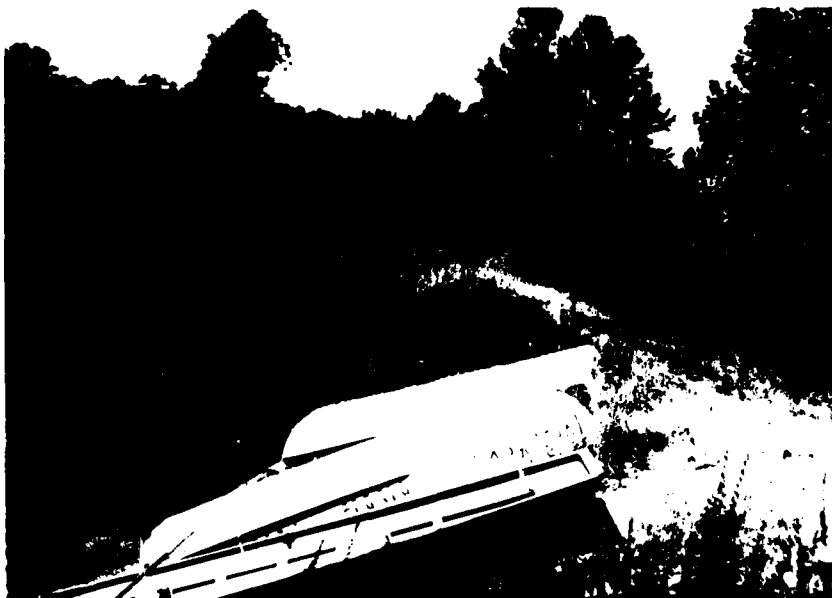
The dam crest has a mowed grass/weed cover with some worn spots, probably due to foot traffic. The embankment material contains rock which provides some slope protection, but wave action erosion was observed on the upstream slope. The upstream and downstream slopes are covered with many large trees and brush. Some trees 4 to 8 inches in diameter were recently cut and some burning of standing brush, trees and stumps was attempted on the downstream slope.

PHOTO 2: UPSTREAM FACE OF DAM LOOKING WEST

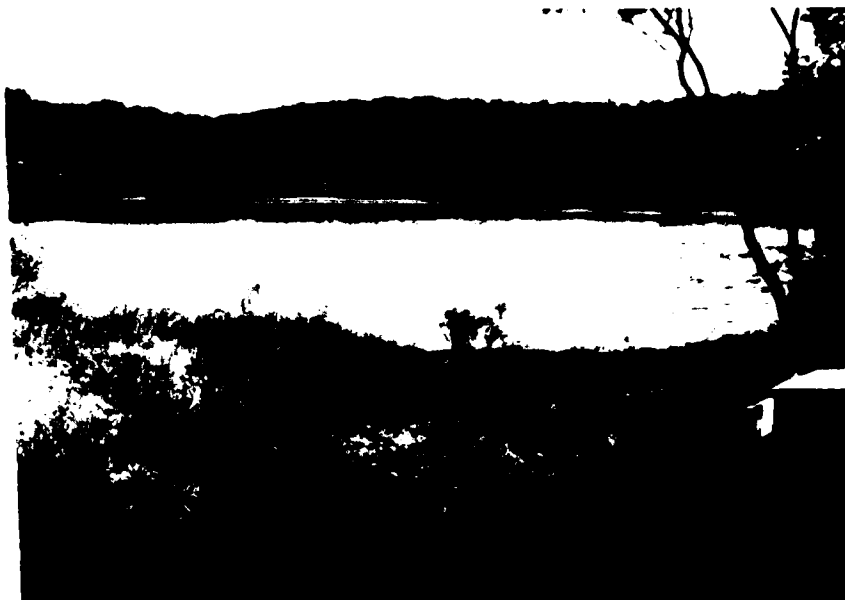
PHOTO 7: SPILLWAY APPROACH LOOKING UPSTREAM FROM CONTROL SILL
